Manhole Inspection Summary

Manhole # S37GG_028MH

Location Address: **1322 GREENMOUTN AVE**

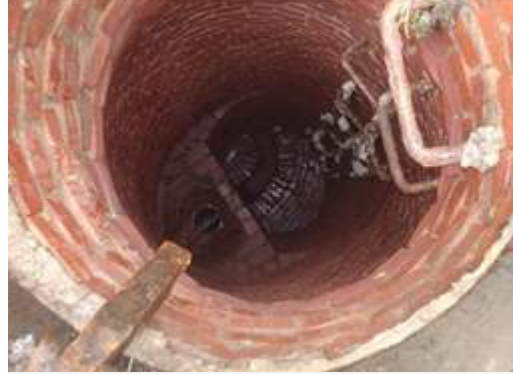
Top View

Condition: ☐ Sound ☐ Cracked ☐ Root Intrusion ☐ Loose Brick ☒ **Deteriorated**

Infiltration: ☐ None ☒ **Joint** ☐ Cracks ☐ Mortar ☐ Roots ☒ **Wall**

Steps Count: **12** Missing: **0** ☒ **Corroded**

Surcharge ☒ **Evidence Of Surcharge** Depth: **18** (ft.) ☐ Active Surcharge Present

Adjustment deterioration and infiltration.
Corroded steps. Evidence of surcharge.

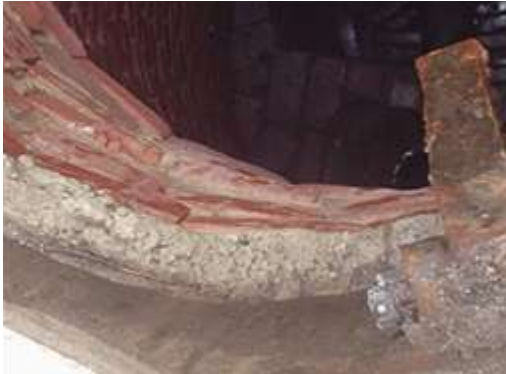
Defect

Frame Offset: **1** (in.)

☒ **Leaks**

Frame leaks. Frame offset.

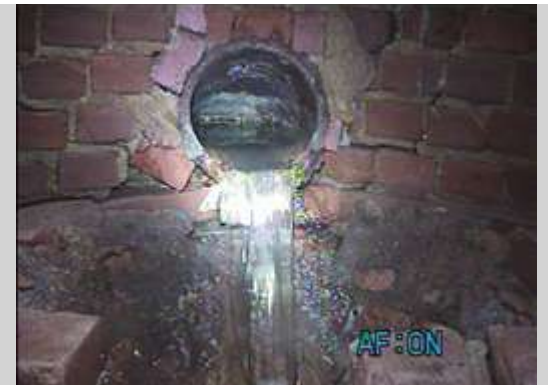
8 in. Circular Gravity Sewer Pipe In @ 8 O'Clock

Deposits: ☐ None ☐ Mud ☐ Sludge ☐ Debris ☒ Grease

Silt Depth: **0** (in.) Deposits Extent: **Light**

Infiltration: **Evidence** Pipe Seal Cond: **Unknown**
